AIRBORNE OCEAN ACOUSTIC MEASUREMENTS
A USER'S REPORT ON SUS RELIABILITY

REPORT No. NADC-76318-20

AIRBORNE OCEAN ACOUSTIC MEASUREMENTS: A User's Report on SUS Reliability

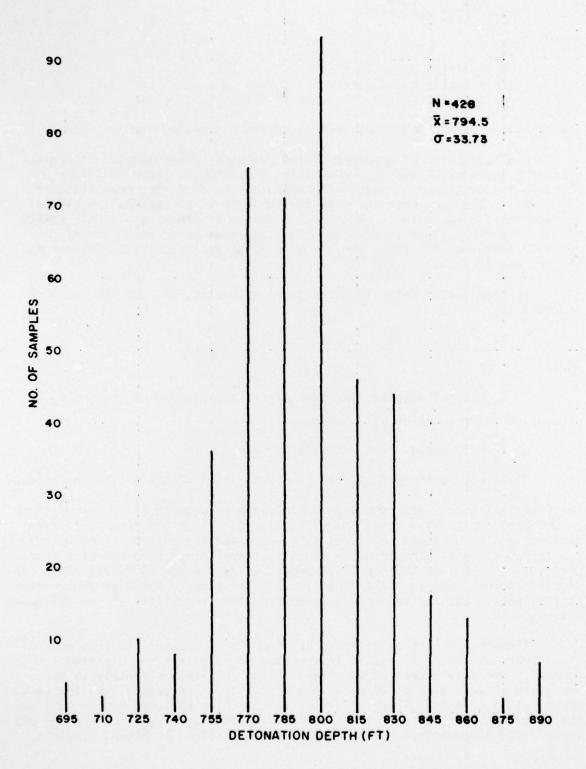
Figure 2. Frequency Distribution of Detonation Depths Near 800 Feet.

The distribution of apparent firing depths is presented as a frequency histogram in figure 2 and as a cumulative distribution curve in figure 3. Although the distribution peaks at a depth of 800 feet, the mean value is 794.5 feet. The fact that the mean firing depth is on the shallow side of the nominal firing depth is consistent with the findings of a CHURCH ANCHOR report. 3 In that study it was found that the mean burst depth for MK 82 SUS (300 feet) was 290 feet, and the mean burst depth for MK 61 SUS set for 60 feet was 58 feet.

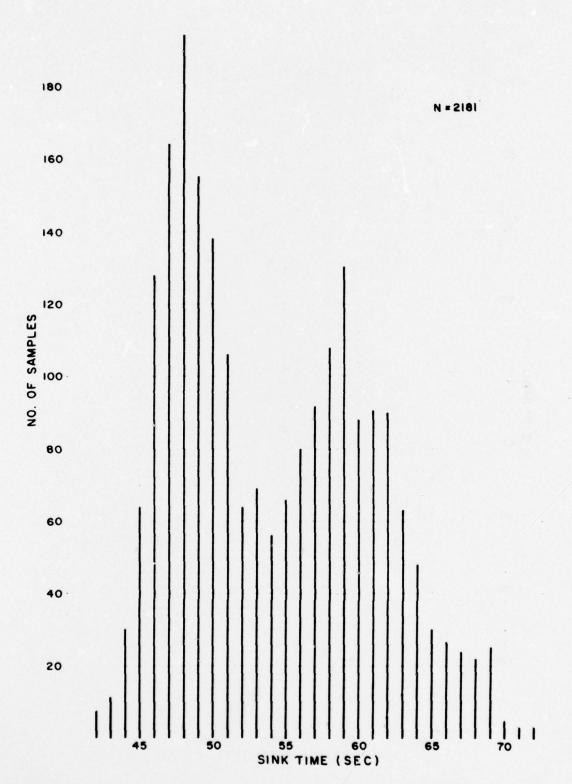
Figure 4. Frequency Distribution of Sink Times to 800 Foot Depth Range.

A frequency histogram of the sink times for the deep (800 feet nominal) SUS appears as figure 4. It is interesting to note that the distribution is bimodal. One peak occurs at 48 seconds which corresponds closely to the specified descent time of 46 seconds \pm 5 seconds. The second, smaller peak occurs at 59 seconds. There is evidently something that happens to some SUS that prolongs their descent times. Possible causes, as suggested in the SUS manual, and by personnel at the Naval Weapons Station, Yorktown, Virginia,

are an increased drag caused by entangled arming wire/drag plate assemblies or drag and/or a spiraling descent caused by damaged tail fin/shroud assemblies. During some acoustic measurement deployments, the arming wire assemblies were intentionally removed by the ordnanceman prior to launch, but slow descents were still found among the resultant shots.

The cause of an abnormally slow sink rate in some SUS, which places a constraint on aircraft measurement techniques and which causes the loss of some data, should be identified and remedied.

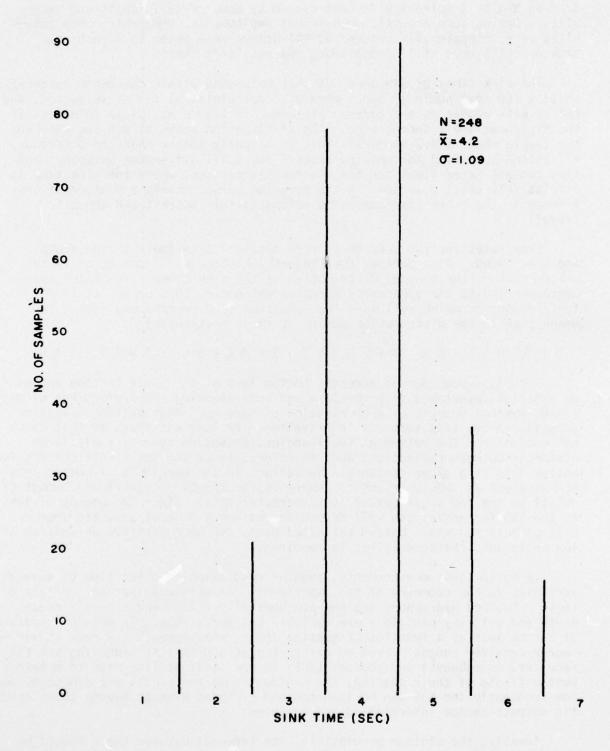
Figure 5. Frequency Distribution of Sink Times to 60 Feet Depth Range.

The sink times of 248 deep SUS that detonated within the depth range of shallow (60 feet nominal) shots were also calculated by the above method, and the results appear as a frequency histogram in figure 5. Class intervals in the histogram are 1 second wide. The distribution peaks at 4.5 seconds, and the sample mean is 4.2 seconds. This is slightly longer than the 3 seconds ± 1 second specified for shallow shots. The small difference between specified and estimated times for the shallow detonations, where the sink time is a relatively small component in the equation, also imparts a measure of confidence in the other time component estimates (air descent and acoustic travel).

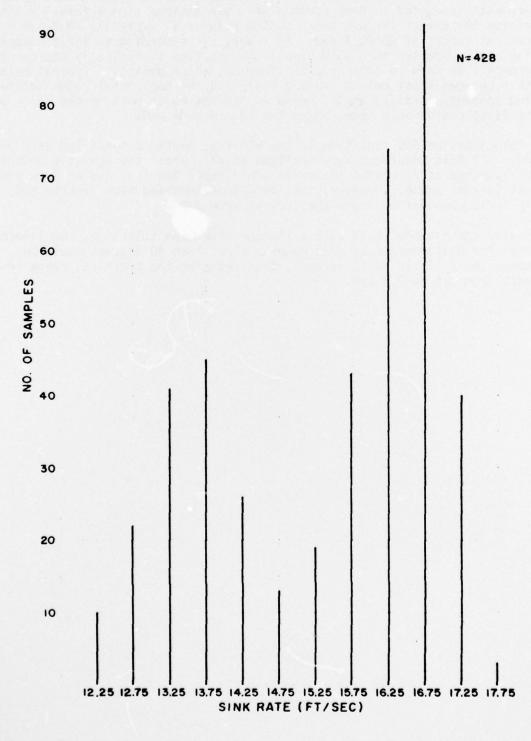
Figure 6. Frequency Distribution of Sink Rates to 800 Feet Depth Range.

Sink rates for the deep shots were obtained from their firing depths and sink times. As expected, the frequency histogram, figure 6, of these values reflects the bimodal distribution of the sink times. The major peak, corresponding to the apparently normally descending SUS, occurs at 16.75 feet/second, agreeing well with the specified 16.8 feet/second rate. The minor peak in the distribution occurs at 13.75 feet/second.

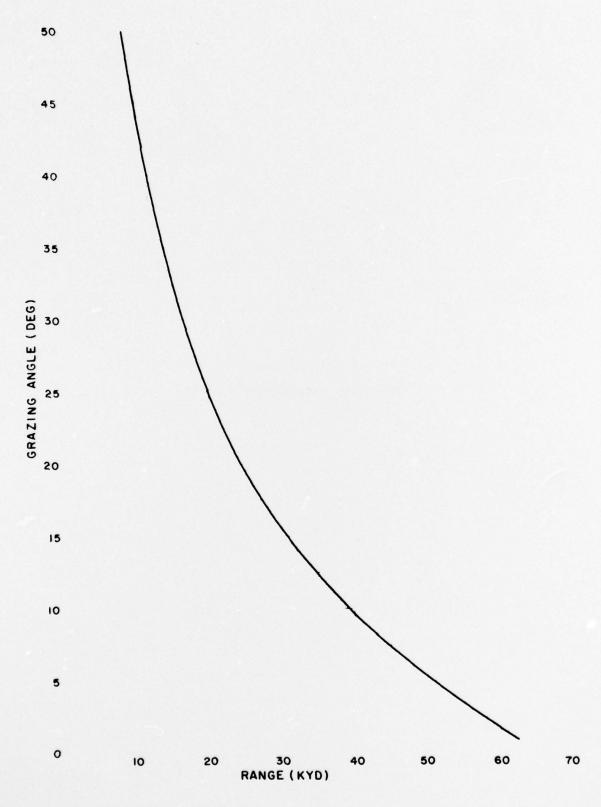
Figure 7. Typical First Bottom Bounce Grazing Angle as a Function of Range.

progression of shots at ever increasing ranges from the acoustic sensor, the duration gradually diminishes from some maximum value. In the NAVAIRDEVCEN measurements conducted in deep ocean areas, the maximum time interval required to receive the direct through third bottom returns is typically 20 to 25 seconds, at ranges of about 4 kyd. At ranges corresponding to first bottom grazing angles smaller than 40 degrees, the interval is typically shorter than 15 seconds. As seen in the curve of figure 7, which depicts a typical relationship between first bottom grazing angle and the horizontal range between SUS and sonobuoy, grazing angles below 40 degrees cover most of the range out to the first convergence zone, where the bounce mode ends.

Tolerances on SUS sink time to the 800 foot depth is specified as \pm 5 seconds. If this tolerance were realized at all times, the acoustic outputs of SUS launched at 30 second intervals would never overlap, and no data would be lost to this cause. However, shallow detonations and slow sinking SUS, singly or in combination cause the loss of some data.

It is also conceivable that, with a tighter sink time tolerance, the launch interval for measurements at grazing angles less than 40 degrees could be shortened to as little as 20 seconds, thus reducing the practical range increments from 3.5 to 2.3 kyd.
